Analysis of Probable Collapse Sequence

COLLAPSE OF WTC 7

World Trade Center 7

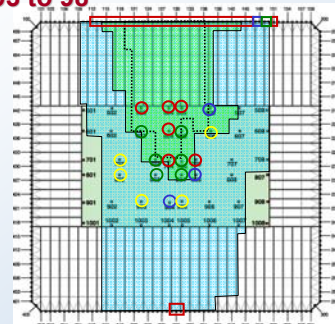
WTC 1 Damage: Composite Summary for Floors 93 to 98

Severe Floor Damage

Fireproofing and partitions

Floor system structural damage

Floor system removed

Column Damage

Severed

Heavy Damage

Moderate Damage

Light Damage

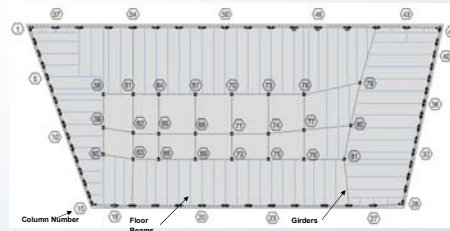
Typical WTC 7 Floor Framing

From the 7th floor to the 47th floor, WTC 7 was supported by 24 interior columns and 58 exterior columns. Columns 58 through 78 formed the building core. Columns 79, 80, and 81 were particularly large and supported long floor spans on the east side of the building.

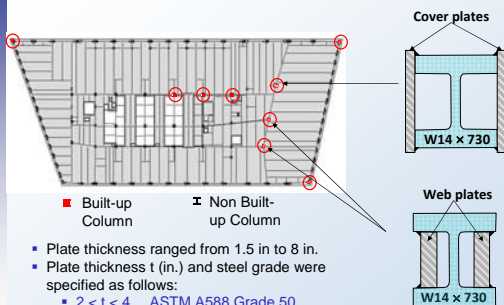
Built-up Columns on Lower Floors

- Built-up Column
 - Non Built-up Column
- Plate thickness ranged from 1.5 in to 8 in.
- Plate thickness t (in.) and steel grade were specified as follows:
 - $2 < t < 4$ ASTM A588 Grade 50
 - $4 < t < 6$ ASTM A572 Grade 42
 - $t > 6$ ASTM A588 Grade 42

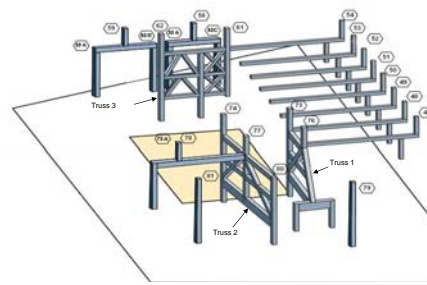
Transfer Trusses and Girders

The layout of the WTC 7 columns did not align with the building foundation and the Con Edison columns. Therefore, a set of column transfers were constructed between the 5th and 7th floor slabs.

- The transfer elements (trusses, girders, and cantilever overhangs) did not play a significant role in the collapse of WTC 7. Likewise, the Con Edison substation did not play a significant role in the collapse of WTC 7.

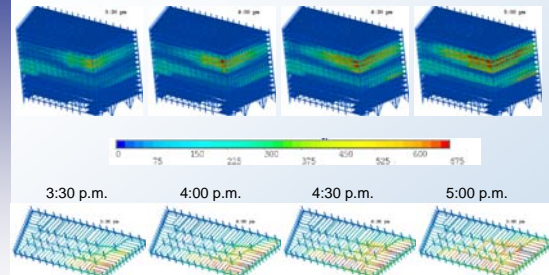
Thermal Response to Fire

Temperature distribution (°C) on the floor beams of Floor 13.

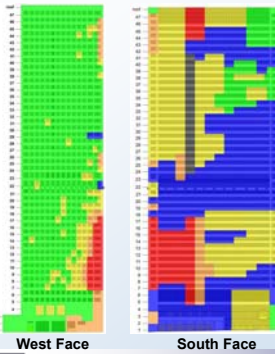
Observed Debris Impact Damage to WTC 7

- green (■) - no visible damage
- yellow (■) - window glass broken
- orange (■) - granite and underlying truss damage
- red (■) - damage to exterior structural steel
- gray (■) - vertical dark band
- blue (■) - not visible due to smoke, dust, and intervening buildings.

- **Collapse of the WTC Towers.**
- Collapse of WTC 2 did not cause any structural damage or start any fires in WTC 7.
- Collapse of WTC 1 damaged seven exterior columns on the lower floors of the south and west faces and initiated fires on 10 floors between Floors 7 and 30.

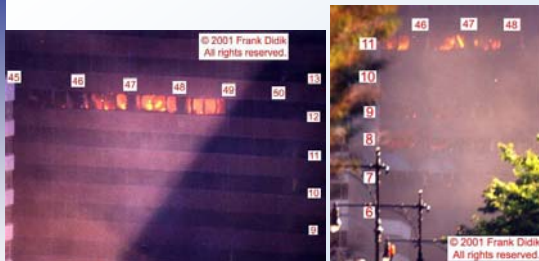
Observed Fires

- Cropped photograph of north face taken between 3:11:15 p.m. and 3:16:51 p.m.

- Cropped photograph showing part of north face at 4:39 p.m. $\pm 120 \text{ s}$.

- **Growth and Spread of Fires.**
- Fires on Floors 7 to 9 and 11 to 13 grew and spread since they were not extinguished either by the automatic sprinkler system or by FDNY because water was not available.
- Fires were generally concentrated on the east and north sides beginning at about 3 p.m. to 4 p.m.
- The local fires on Floors 19, 22, 29, and 30 were not observed after ~ 1 p.m.

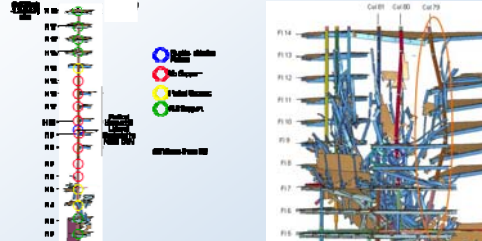
- **Initial Local Failure for Collapse Initiation.**
- Fire-induced thermal expansion of the floor system surrounding Column 79 led to the collapse of Floor 13 and triggered a cascade of floor failures.
- This, in turn, led to loss of lateral support to Column 79 over nine stories, resulting in the buckling failure of Column 79.

- Unlike the WTC towers, there was no dispersion of jet fuel in WTC 7 causing simultaneous fire initiation over extensive areas of multiple floors.
 - The probable collapse sequence was initiated by the buckling of Column 79, which was unsupported over nine stories, after local fire-induced damage led to a cascade of floor failures.**

- The buckling of Column 79 led to a vertical progression of floor failures up to the east penthouse and to the buckling of Columns 80 and 81.
 - An east-to-west horizontal progression of interior column buckling followed.
