Nepal Earthquake Building Safety Assessment

by Sabina Surana
May, 2015

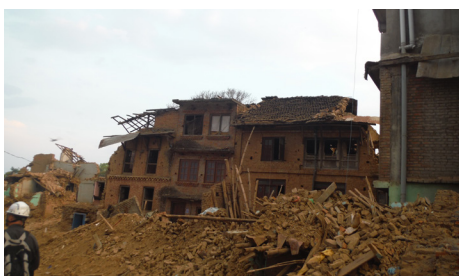
Traditional Newari houses constructed with brick and mud mortar in Dharmasthali, Kathmandu.

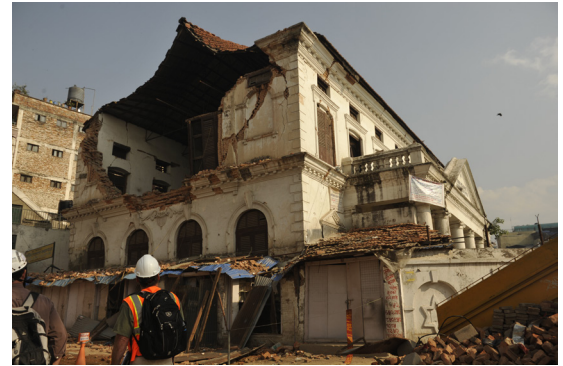
The side view of Durbar High School in Ranipokari, Kathmandu, one the first high schools to provide modern education in Nepal.
